Gale Tree Consultancy

Tree Condition Report

Nuthurst Parish Council

September 2020

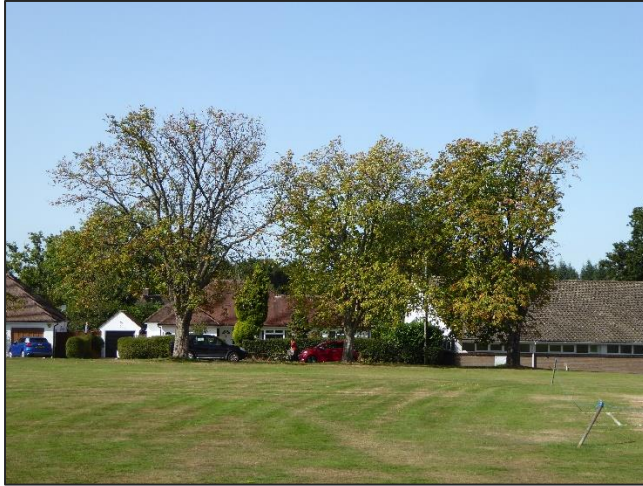
Mannings Heath Recreation Ground

- Horse chestnut trees can suffer from several pathogens which on their own, aren't necessarily damaging, yet combined can cause significant problems
- Horse chestnut leaf miner (HCLM) and Horse chestnut leaf blotch (HCLB) do not kill the tree. However, in advanced cases it can hinder photosynthesis and in doing so increase stress levels which can result in a tree that is more susceptible to secondary pathogens

- Chemical applications are possible but I do not believe this necessary or practicable
- Horse chestnut bleeding canker (HCBC) is a bacterium that first came to prominence in the 2000's. In extreme cases, where the cankering lesions girdle the entire stem, it can cause the failure of the host tree. However, most trees recover from the infection and others appear to be resistant

- Horse chestnut do not have a durable heartwood and as such, any large wounds, whether via pruning or natural causes, are prone to decay forming as the wound wood cannot occlude before the decay process begins

- This is evident in T5/181 where the decay that is forming extends to c.30cm into the stem and 42cm down the stem. Even though the tree is producing wound wood around the cavity, it will never fully occlude and the decay will continue

Horse chestnut trees adjacent to Golding Lane exhibiting various stages of HCLM, HCLB and HCBC

- Treatment can involve a number of approaches, most notably collecting the leaves and burning them or placing them in sealed bags until the summer of the next year after which the moths would have emerged and died

- Although I do not consider there to be an immediate need for a detailed decay evaluation, it would be wise to determine the extent of any decay that may be migrating away from the initial point of wounding. This can be achieved by using a Resi microdrill and should ideally be undertaken before the next inspection

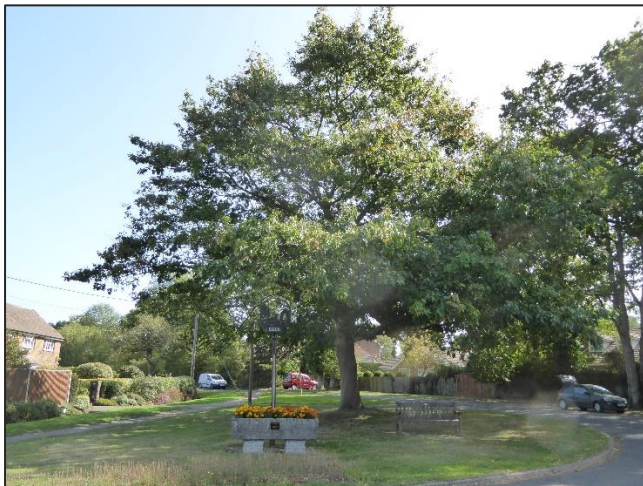
Jubilee Tree Church Road/Winterpit Lane

Tree No	Tag No.	Species	Stem Diameter	Height	Crown Spread	Age Class	Phy. Cond.	Comments	Action Required	Priority
14	190	Red oak	751-850	10-15	10-15	SM	GOOD	Deadwood in crown	Remove deadwood greater than 25mm in diameter	HS2

- Deadwood is a natural phenomenon and as such its presence should not raise alarms bells. However, where large diameter branches decline and die over a short period of time, the causation should be explored to ascertain whether any underlying issue is in effect
- At the time of inspection, I am of the opinion that the deadwood present is not related to an underlying issue and should be removed in the time frame specified

The deadwood is located predominately within the central area of the tree

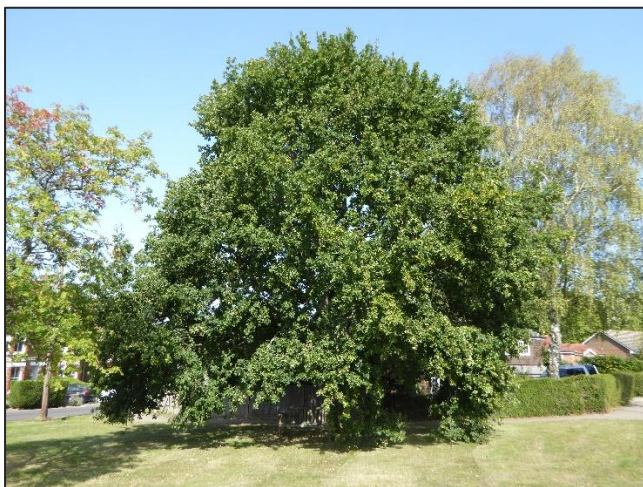
Memorial Tree Church Road/Lime Kiln Road

Tree No	Tag No.	Species	Stem Diameter	Height	Crown Spread	Age Class	Phy. Cond.	Comments	Action Required	Priority
15	191	Pedunculate oak	451-550	10-15	10-15	EM	GOOD	Low branching Minor deadwood in crown	Crown lift to 2.0m above ground level by removing subordinate branches only	HS2

- The branches are low to the ground and as such pose a risk of eye/head injury and an encumbrance for ground maintenance
- To achieve the desired crown lift, subordinate branches should be removed back to suitable secondary growth in line with BS3998:2010 Tree Work – Recommendations

The low crown which could result in eye/head injury

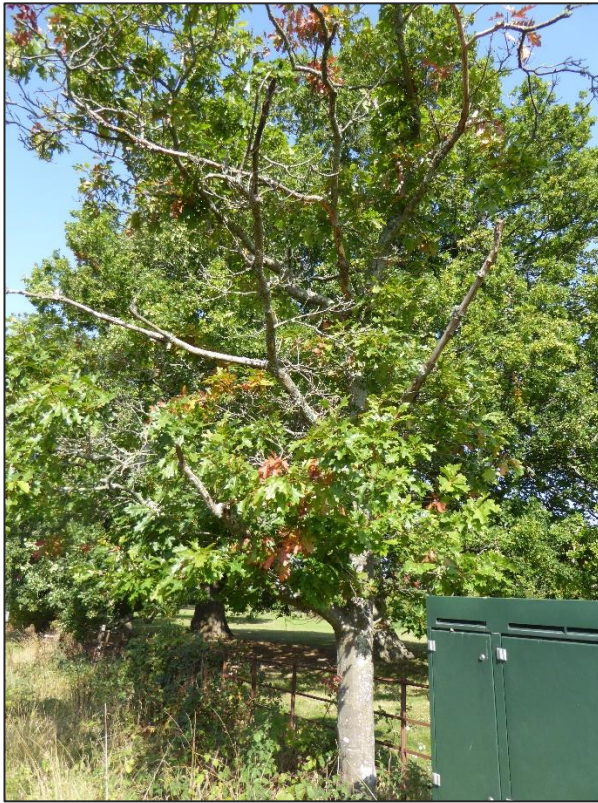
Memorial Tree Monks Gate/Brighton Road

Tree No	Tag No.	Species	Stem Diameter	Height	Crown Spread	Age Class	Phy. Cond.	Comments	Action Required	Priority
16	192	Red oak	251-350	5-10	0-5	EM	POOR	Declining crown with large diameter deadwood	Remove dead wood and shorten the higher branches to achieve a more balanced crown form	HS2

- The Red oak is in a poor condition with a declining crown and large diameter deadwood noted
- It is unclear why the tree is in such a poor condition but the presence of multiple telecommunication installations so close to the trees rooting area cannot be discounted as a possible cause of root disturbance
- Therefore, in an attempt to establish a more compact crown form, the deadwood should be removed back to sound wood and the remaining declining branches reduced. This may have the desired effect however, if the possible root damage is significant, the tree may decline further

Deadwood and declining crown branches are evident – note the telecommunications installation close to the base of the tree

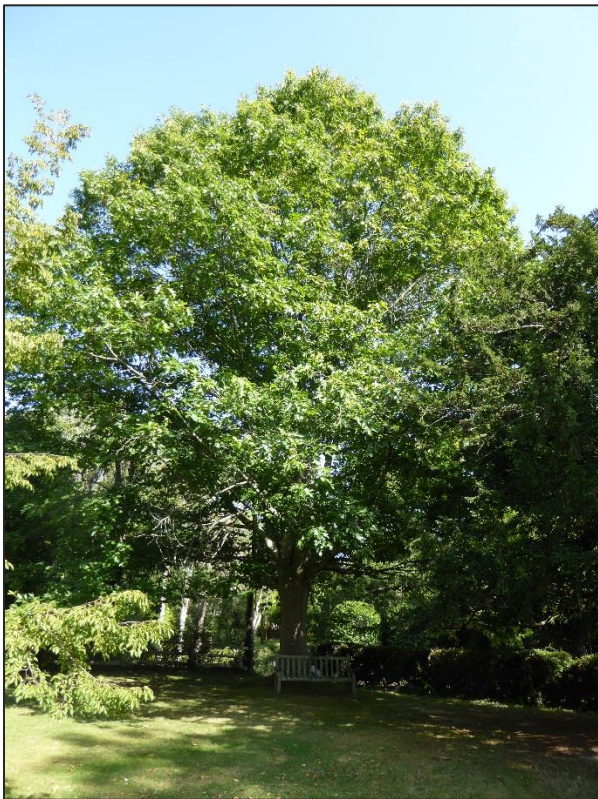
Memorial Tree St Andrew's Church Nuthurst Street

Tree No	Tag No.	Species	Stem Diameter	Height	Crown Spread	Age Class	Phy. Cond.	Comments	Action Required	Priority
17	193	Red oak	651-750	15-20	10-15	M	GOOD	Desire line to north Bench to south beneath crown Stem bifurcates c2.5m into 3 primary stem sections, minor included unions Deadwood and storm/vehicular damage over road	Remove deadwood greater than 25mm in diameter Remove storm damage Crown lift to 5m over road	HS1

To the east of the tree is Nuthurst Street where a section of small diameter storm/vehicular damage was noted

- A small section of storm damage/vehicular damage was noted over the Nuthurst Street and should be removed
- To minimise the risk of vehicular damage, the lower crown over Nuthurst Street, should be lifted to produce a clearance of 5m. This should be achieved by removing subordinate branches back to suitable secondary growth in line with BS3998:2010 Tree Work – Recommendations

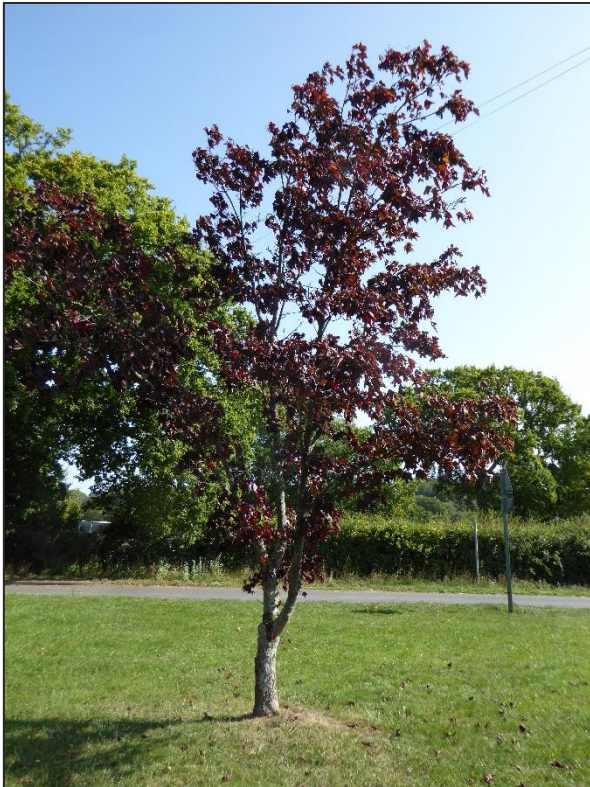
Memorial Tree Nuthurst Road/Copsale Road

Tree No	Tag No.	Species	Stem Diameter	Height	Crown Spread	Age Class	Phy. Cond.	Comments	Action Required	Priority
18	194	Norway maple 'Crimson King'	150-250	0-5	0-5	EM	GOOD	Grass around basal area Deadwood less than in 10mm within crown Earth mounded south side	Remove mounded earth and establish a clear area around the basal area of the stem	GM

- The tree is a young planting located within a grassed area. On the south side of the tree, earth appears to have been piled around the basal area resulting in the lack of buttress root development
- The piling of earth around the basal area of trees should be avoided as it restricts the natural development of stem flare and buttress roots, plus it can increase the risk of pathogen colonisation
- The earth should be pulled away from the stem base and ideally, a 1m radius (2m diameter wide) area of grass cleared to help develop a sound rooting system and lower stem structure. This should be kept clear of grass to encourage good tree development

Note the slight mounding of earth to the south of the tree

Achieving good growing conditions for a young tree is essential for its development

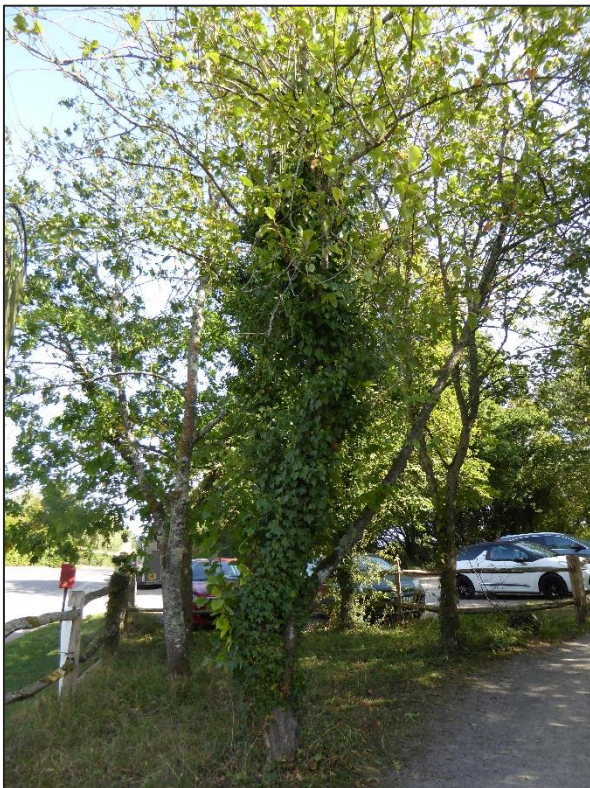
Jubilee Tree Downs Link car park

Tree No	Tag No.	Species	Stem Diameter	Height	Crown Spread	Age Class	Phy. Cond.	Comments	Action Required	Priority
19	195	Bird cherry	150-250	5-10	5-10	EM	FAIR	Minor basal wound ground level west side depth 15mm Multi stem two primary stem sections and one tertiary stem section	Sever ivy at ground level and again at 1m, removed severed band	HS1

Tree No	Tag No.	Species	Stem Diameter	Height	Crown Spread	Age Class	Phy. Cond.	Comments	Action Required	Priority
								Thick ivy restricts a thorough basal assessment Ivy into high crown c.60% Declining branch ends on the north and north west side of the crown

Ivy advancing into the upper crown increasing the sail and volume of the tree

- Where it has been recommended, the ivy should be severed as close to the ground as possible and again at 1m with the severed band being removed. This will allow the ivy ascending into the tree to die off naturally whilst the gap generated will allow any new ivy to be severed if/when it appears
